Science and Management Technical Series

Number 9

Experimental Farm Rock Toe Protection as an Erosion Control Option for Missouri Streambanks

J. Persinger, K. Grmusich, C. Culler, and B. Jamison

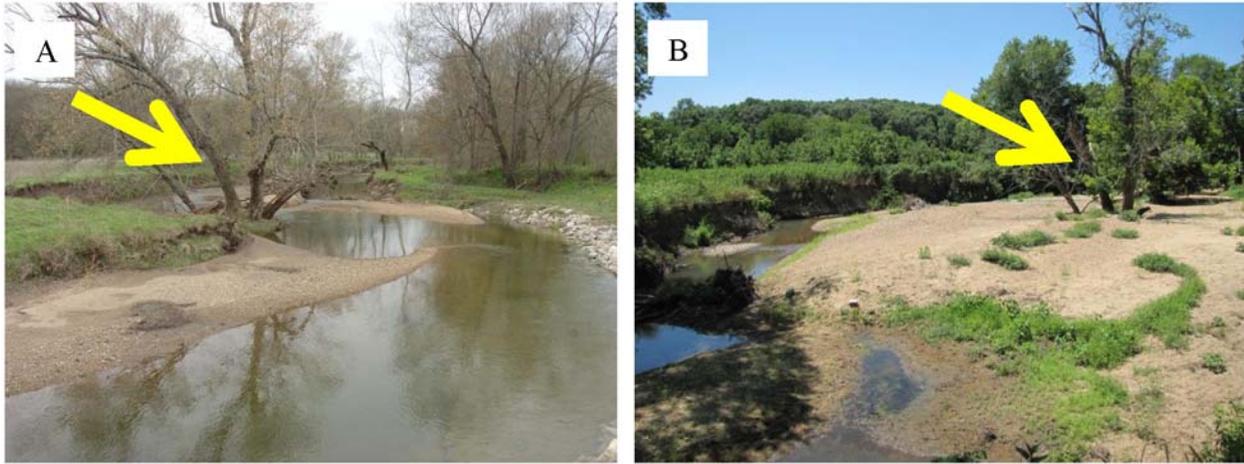
Figure 4. Photos of the stream approach to the Starks Creek farm rock toe project. (A) Looking upstream of project in April 2007. (B) Looking upstream of project in July 2011. Yellow arrow is pointing at same tree.

out, changing the streams approach to the project. These changes continued in the fall of 2008 as the streambank directly upstream began to fail as well. Starks Creek had three more flows in 2009 that went over the top of the bank. Included in this was a flow with a stage over 14 ft. which represents the highest flow recorded at this site during the study. This flow caused the opposite streambank upstream of the project to completely fail causing dramatic change in the stream's approach to the project (Figure 4). In both 2010 and 2011, the project was only tested by a single high flow event. These flows continued to cause changes to the streambank upstream of the project. GIS maps from September 2006, June 2008, July 2010, and July 2011 show how much change has occurred in the channel upstream of this project (Figure

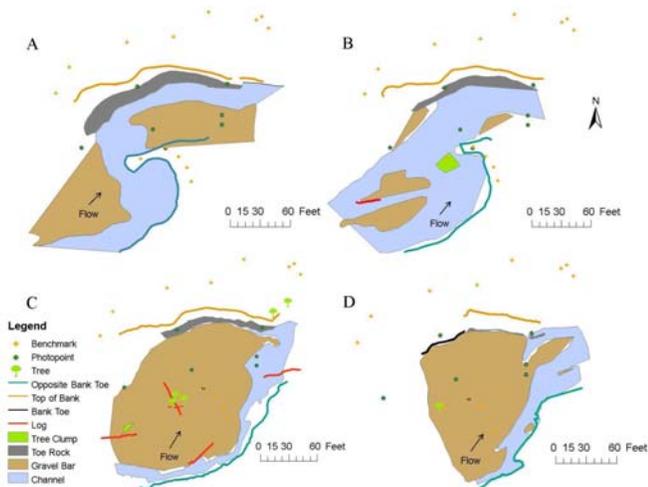
Figure 5. GIS maps of the Starks Creek farm rock toe project. (A) Post-construction map September 2006. (B) Channel changes June 2008. (C) Channel changes July 2010. (D) Channel changes July 2011.

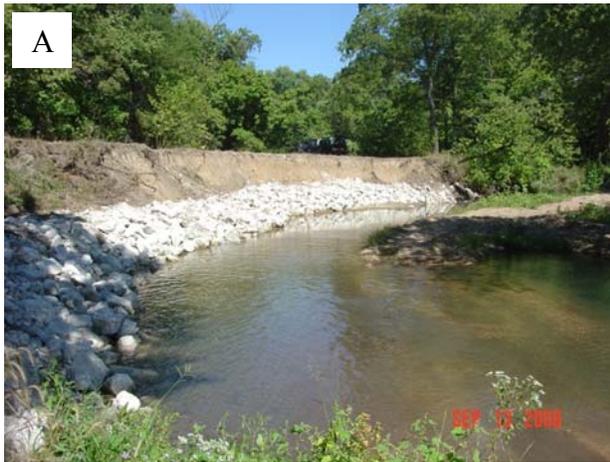
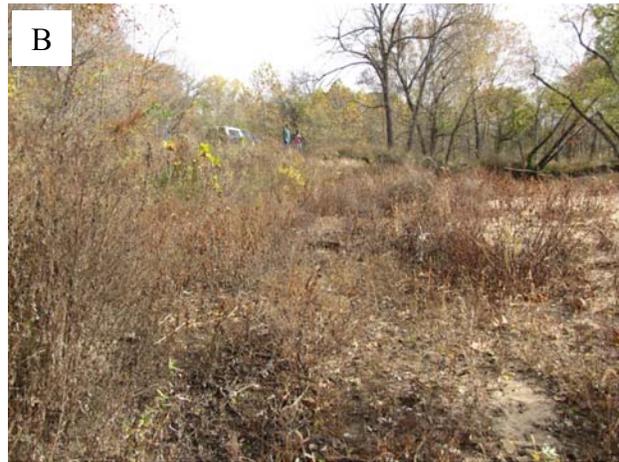
Despite large amounts of erosion occurring on the banks surrounding this project, this site has remained stable. For the first two and a half years the project survived numerous high flows and performed as planned. The thalweg shift that occurred in 2009 resulted in large amounts of deposition at the toe of the streambank and between the streambank and the new channel. The physical surveys, which were conducted post-construction and following flow events each year from 2007-2011 show how the channel shifted away from the bank. The original thalweg that was against the streambank has filled in with deposition and in places it has shifted more than 100 ft. away from the bank. The survey data appear to show that there has been erosion at the toe of the streambank for five of the seven transects (Table 2). However this movement is actually due to deposition of material that has formed a new gravel bar in front of the eroding streambank and that has covered up the original toe of the bank, resulting in the toe moving back and up the streambank (Figure 7). This is confirmed by the fact that the slope has been reduced for six of the seven transects with the other transect remaining the same.

Figure 6. Photos of the Starks Creek farm rock toe project. (A) Looking downstream following construction in September 2006. (B) Looking downstream in October 2011.

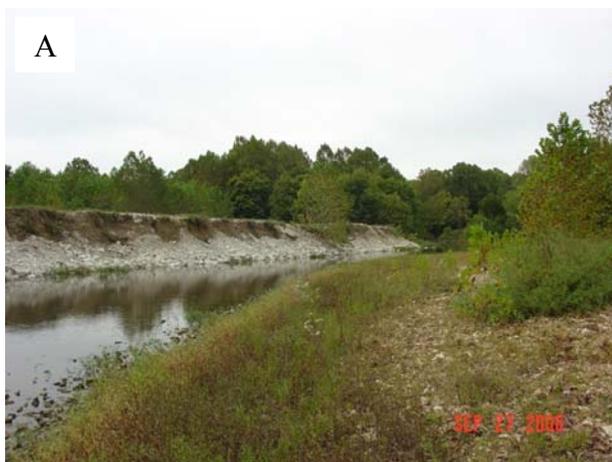
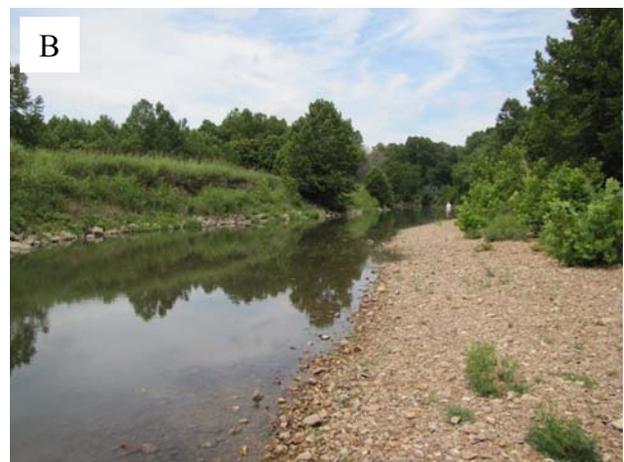
flow events in 2007 reached a stage between $\frac{3}{4}$ the height of the streambank and the top of the bank. The project was tested by numerous flow events in 2008, including six that went over the top of the bank. The largest of these flow events reached a stage >16.5 ft. and represented a 14 ft. rise over the average flow during the previous week. In 2009, the project was tested by two flow events that went over the top of the bank, one of which was over 16 ft. in stage. In 2010 and 2011, the project was tested by two more flow events each year that topped the eroding bank. The project survived all of these flow events and appears to be working as planned (Figure 9). The number and size of the flow events that have tested this project have given an excellent baseline for evaluating the performance of this project.

Figure 9. Photos of the Weaubleau Creek farm rock toe project. (A) Looking downstream following construction in September 2006. (B) Looking downstream in August 2011.

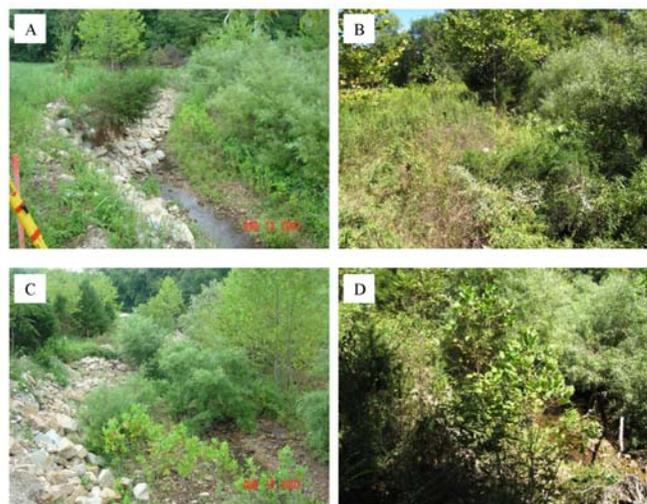
ed by a flow event that went over the top of the bank. There was no large flow events recorded in 2011. The small number of flow events that have occurred on this stream makes it difficult to assess the success of this project.

Figure 12. Sulphur Branch farm rock toe project. (A) Looking upstream following construction in August 2007. (B) Looking upstream in September 2011. (C) Looking upstream following construction in August 2007. (D) Looking upstream in September 2011.

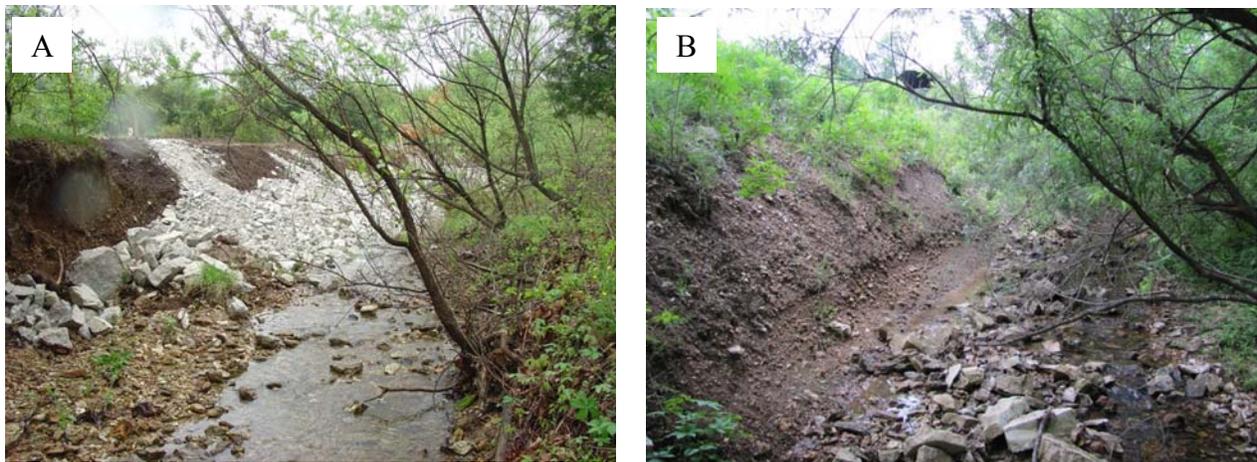
While the toe rock project has prevented toe erosion up until this point, it has sustained damage at the downstream end of the project (Figure 14). The project has lost a large portion of the original rock in some places, particularly at the downstream end of the project. So far this loss of rock has not resulted in damage to the bank, but has left the project vulnerable to damage. The loss appears to be due to inadequate

Figure 14. California Branch farm rock toe project. (A) Looking upstream following construction in May 2007. (B) Looking upstream in June 2011.

rock size. The rock used was simply not large enough to stay in place and was picked up and moved downstream. Insufficient rock size appears to be the biggest issue with the approach of using shot rock instead of rip rap to build farm rock toe projects. The physical surveys, which were conducted post-construction and following flow events each year from 2008-2011, demonstrate the lack of streambank movement and the stability of the channel despite the loss of rock (Figures 15). Streambank movement has been minimal and was caused almost exclusively by the loss of rock. This rock loss has resulted in a slight increase in streambank slope along transects five and six (Table 5). The slope of the streambank at the other transects has remained virtually unchanged and vegetation is beginning to establish in the toe rock that is still in place.

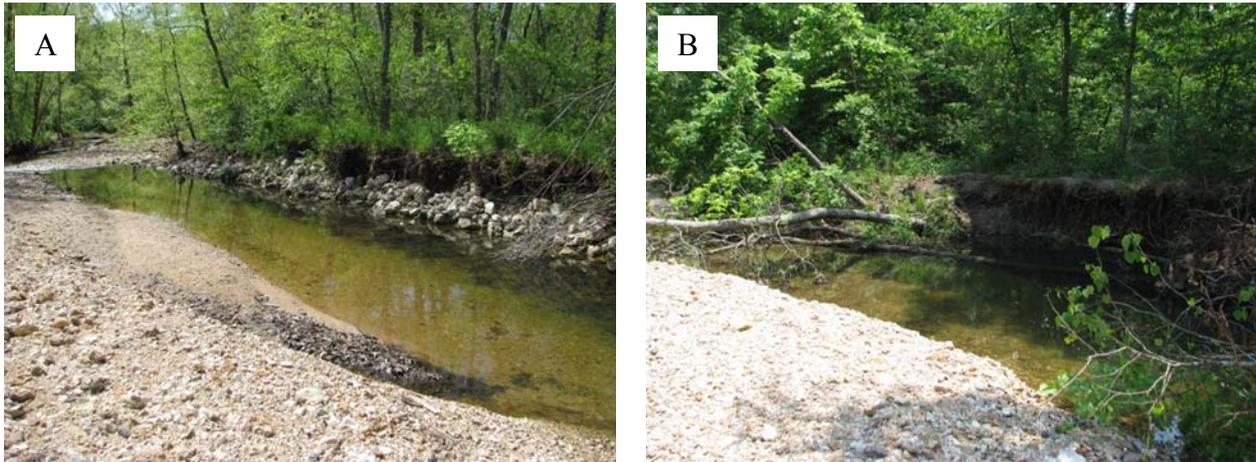
streambank (Figure 16). The toe rock project held up during all of these flow events and appeared to be working. However, in May of 2009 the project was tested by the largest flow that occurred during the study, which caused the failure of the project. The failure started midway down the project causing the rock along the entire lower half of the project to dislodge (Figure 17). The project appears to have failed due to insufficient rock size. In the middle of the project at approximately the apex of the bend, the rock began to be lifted away from the streambank by the force of the flow. All the rock on the lower half of the project was carried away and deposited downstream in the next gravel bar. Once the rock was removed the streambank began to erode rapidly causing several trees to fall into the channel.

Once the failure process started on the downstream end of the project it continued during all the subsequent flow events. The physical surveys, which

Figure 17. Fiery Fork 1 farm rock toe project. (A) Lower end of the project post-flow in May 2008. (B) Lower end of the project post-failure in June 2009.

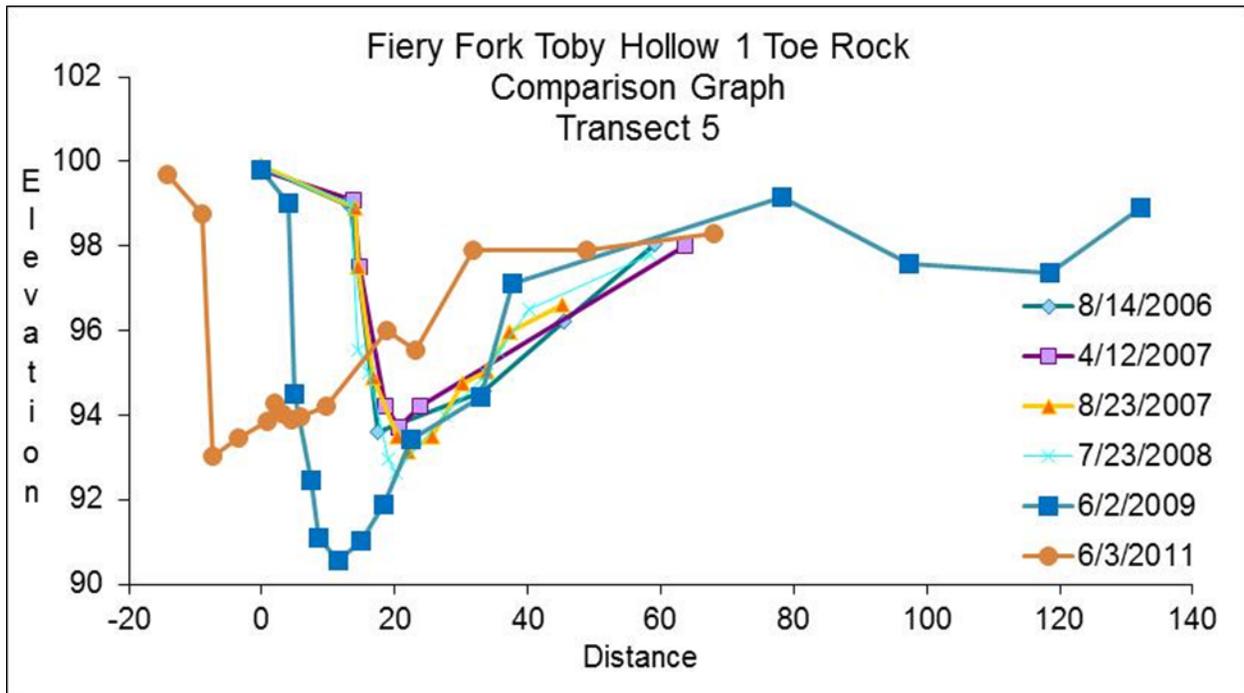
Figure 18. Physical survey data for transect five for the pre-construction survey (8/14/2006), post-construction survey (4/12/2007), two post-flow surveys (8/23/2007 and 7/23/2008), and two post-failure surveys (6/2/2009 and 6/3/2011).

were conducted post-construction and following flow events in 2008, the failure in 2009 and a final survey in 2011, provide evidence of the channel changes that resulted from the failure (Figure 18). There has been minimal streambank movement along the first three transects, where the rock stayed in place, and it has resulted in the streambank slope being reduced. Transects four through six show the dramatic changes caused by the project's failure. Transect four is located directly below the start of the failure and has seen a large increase in slope in addition to the erosion. Transects five and six have had a much higher erosion rate, over 20 ft. of erosion, than transect four and have also seen a dramatic increase in slope (Table 6).
