Science and Management Technical Series

Number 8

Experimental Farm Rock Weirs as an Erosion Control Option for Missouri Streambanks

J. Persinger, K. Grmusich, C. Culler, and B. Jamison

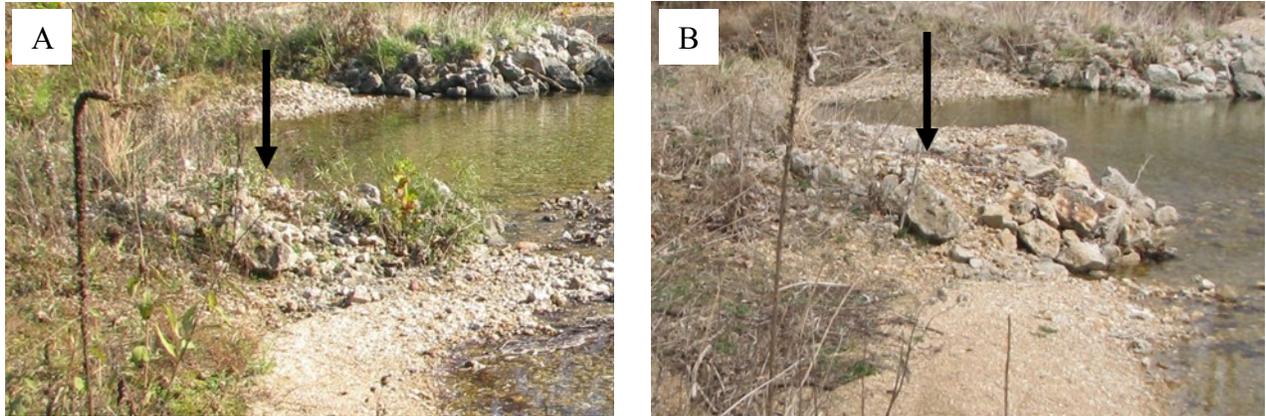
Weir two lost approximately 7 ft. of length between project construction and the 2008 physical sur-

vey (Figure 3); however, the weir had been built longer than the original design and the project was still working as expected so there was no plan to repair the project. An unplanned repair was made to weir two between October 2008 and March 2009. The repair consisted of adding approximately 4 ft. of length back to weir two (Figure 4). The repair was made by area staff without consulting with the rest of the project team.

Figure 4. Photos of Jakes Creek site 1 weir two before and after unplanned repair. (A) Weir two October 2008. (B) Weir two March 2009. The arrows are pointing to the same rock in each photo.

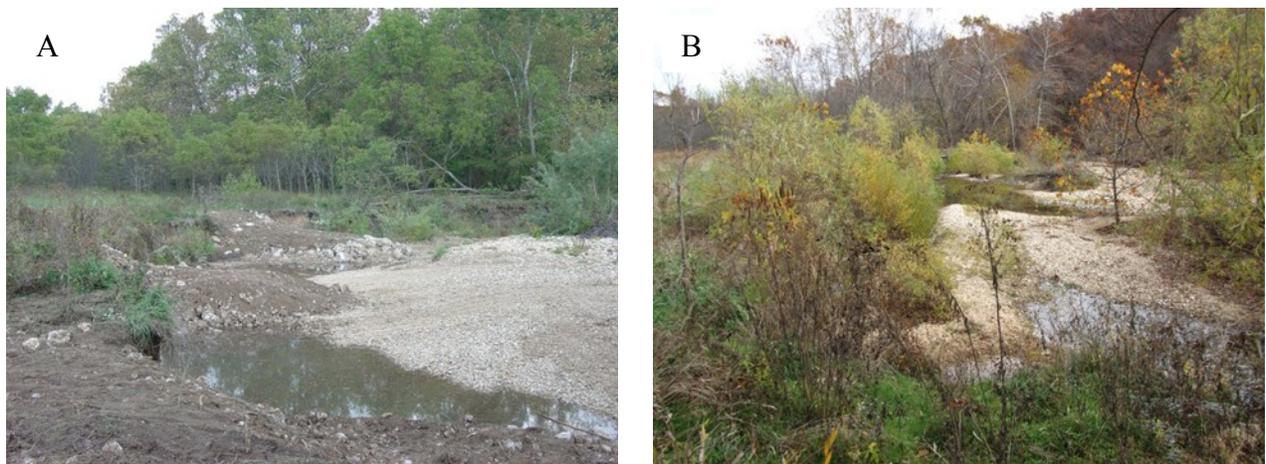
Photo monitoring gives a good visual representation of how the channel has responded to the project in a positive manner (Figure 5). The photos show that the thalweg has moved away from the eroding stream-

Figure 5. Monitoring photos for Jakes Creek site 1 farm rock weir project. (A) Looking downstream following construction in October 2005. (B) Looking downstream in October 2011.

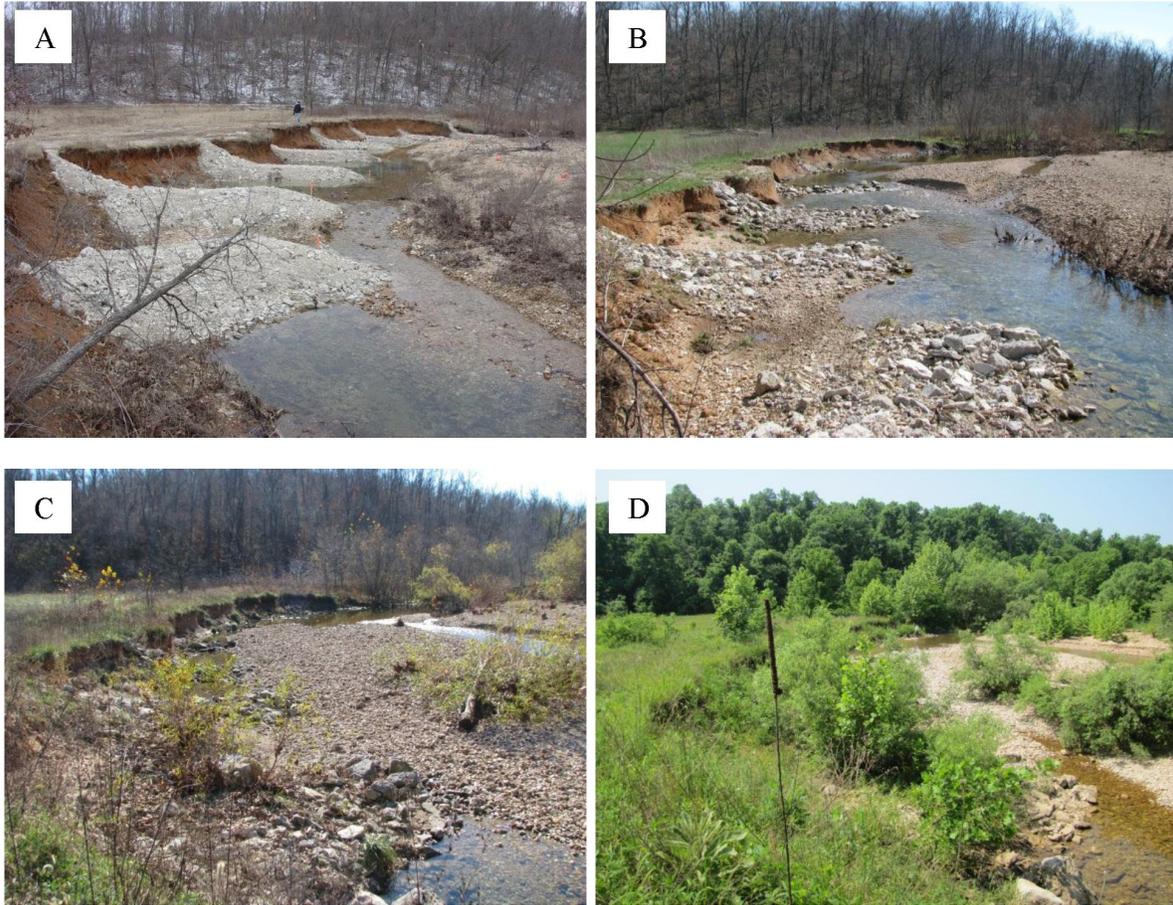
During 2008, some of the stream flow was redirected away from the eroding streambank and through the opposing gravel bar. The shift occurred downstream of the first two weirs and appears to be a result of the project in combination with channel changes upstream of the project. Since 2008, the percentage of the flow that is taking the new channel has continued to grow. A GPS map created following project construction in 2007 shows the location of

Figure 8. Jakes Creek site 2 (A) Looking upstream following project construction February 2007. (B) Looking upstream April 2008. (C) Looking upstream November 2009. (D) Looking upstream June 2011.

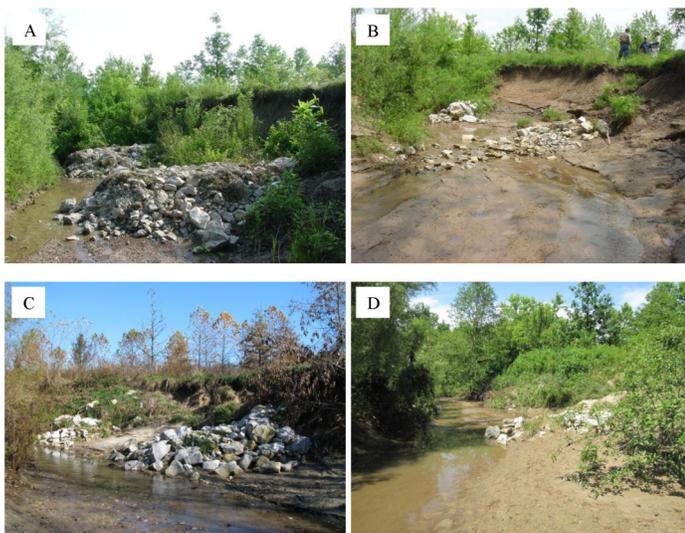
The Dry Branch rock weir project was the first rock weir project to fail. The project survived two flow events that were greater than $\frac{3}{4}$ the height of the streambank before a failure occurred following the flow event on May 6, 2007. This rain event created an approximately 10.5 ft. rise over the average flow during the previous week. The stage rose from approximately 1 ft. to a height of 11.5 ft. in two hours, which represents a flow 2.5 ft. above the top of the streambank (Figure 10). The flow caused extensive damage to the project and resulted in its failure.

Following the failure of the project in May 2007, a post-failure survey was conducted. A visual inspection of the project following failure as well as the data collected during the survey made it clear that the project did not fail because flow cut under or behind the project, but because water picked up all but the largest pieces of rock and carried them away (Figure 11). Because of the nature of the failure, the project was repaired by rebuilding it with larger rock on September 12, 2007.

Figure 11. Monitoring photos from Dry Branch farm rock weir project. (A) Looking upstream following construction in July 2006. (B) Looking upstream following failure in May 2007. (C) Looking upstream following repair in October 2008. (D) Looking upstream in July 2011.

more than a rock hard point and weir two has lost both height and length (Figure 11). In addition, flow coming off the field behind the streambank has caused erosion between weir one and two (Figure 12). This erosion has contributed to flow getting behind weir two and eroding the bank

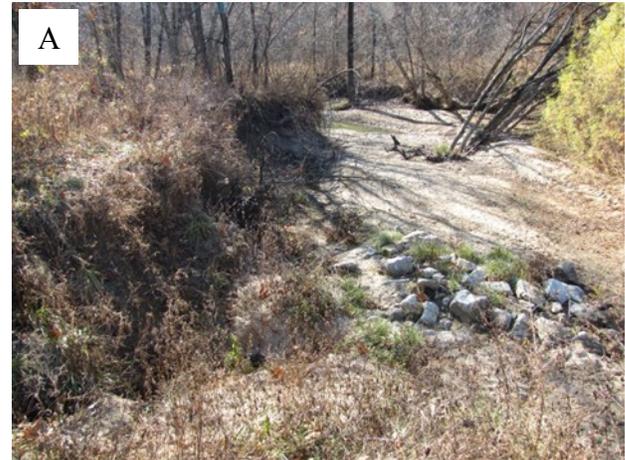
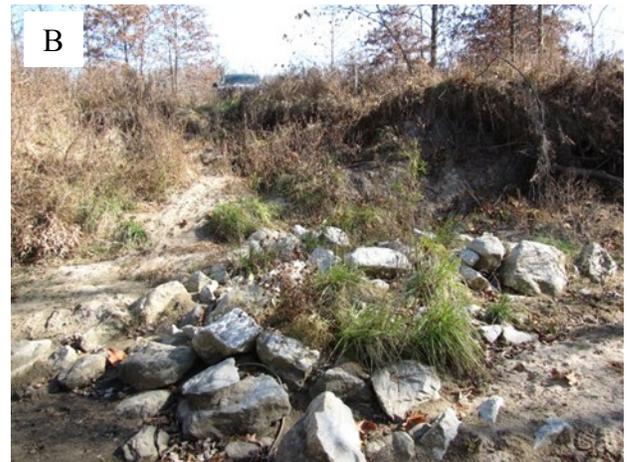
Figure 12. Eroded area at the Dry Branch farm rock weir project caused by flow coming off a field behind the bank. (A) Looking at erosion from top of the streambank November 2011. (B) Looking at eroded area from the channel November 2011.

There have been dramatic changes in this project since initial construction. The project has slowly moved toward failure even after repairs were made. Upstream of weir two the bank's slope has decreased since original project construction, but from weir two downstream the slope has increased (Table 4). There has been a large amount of erosion at both the top and toe of this streambank since original construction, which could be expected given that it failed once and was repaired. However, if you compare the changes that have occurred since construction with those since the project has been repaired you can see that the majority of the erosion has occurred since project repair (Table 5). The erosion caused by the field runoff has

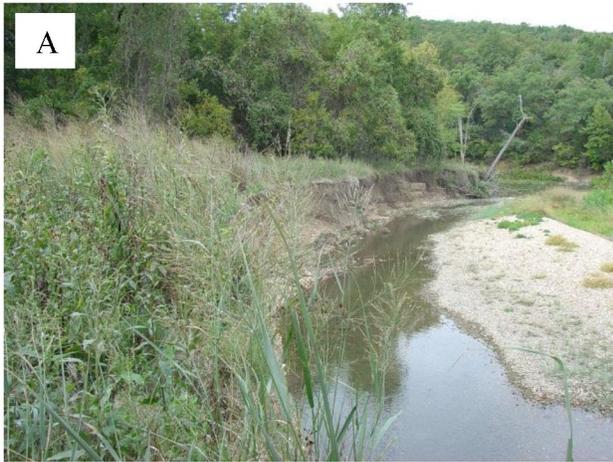
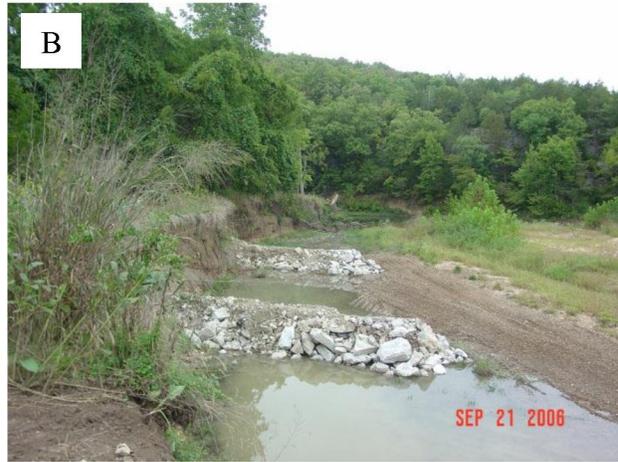
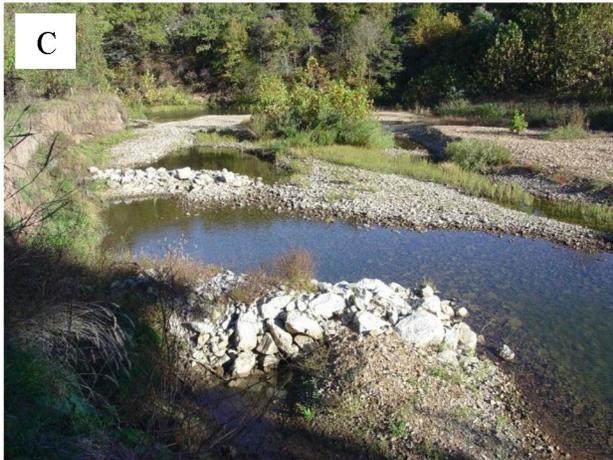
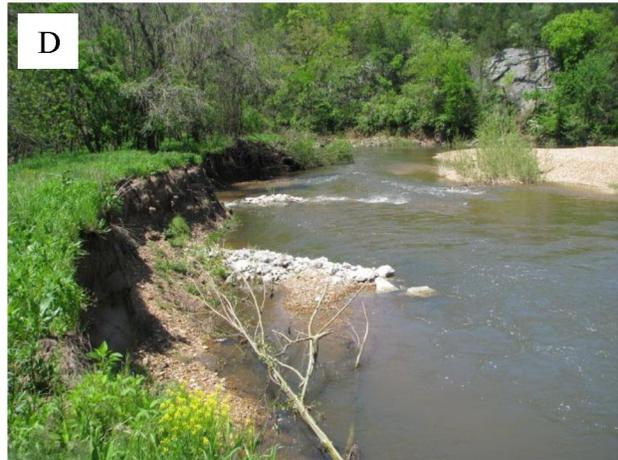
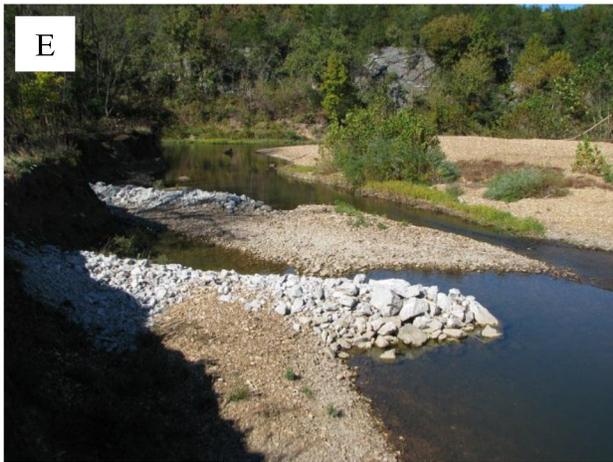
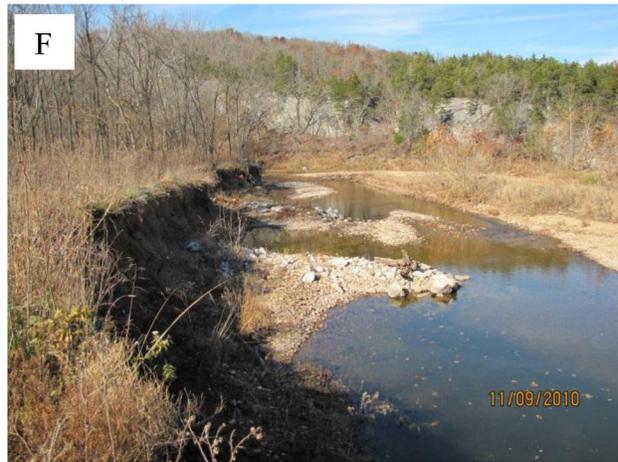
The Weaubleau Creek project experienced three flow events that were more than $\frac{3}{4}$ the streambank height in 2007 as well as two more in early 2008 (one of which went over the top of the bank, 10 ft.) before failing at the end of March in 2008 (Figure 13). The project started to fail during this flow event due to changes that had occurred as a result of previous flow events. Because farm rock weirs are not initially keyed into the bed of the stream the way that traditional bendway weirs are, the streambed around the tip of the weir developed a scour hole from velocity currents going around the weir. The rock off the tip of the weir

then fell into the hole created by the scour and eventually protected itself from any further scour. However; this process causes the weir to lose some of its effective length. In this case, weirs three and four lost enough length to allow flow to get behind weir five (Table 6, Figures 14, 15). The loss of length caused weir five to fail.

Despite flow getting behind weir five, the rest of the project performed as planned. The thalweg had shifted away from the eroding streambank and deposition occurred between all other weirs. As a result, the project was repaired by rebuilding weir five and adding length to weir four in August 2008. After repairs were completed, the largest flow occurred in September 2008 and the project survived without further damage. The project was tested by two flows greater than the top of the bank, one of which was over 16 ft. in stage in 2009, and by three more flows that were greater than the top of the streambank in 2010. Despite the failure and repairs to fix weirs four and five in 2008, this project appeared to be working prior to 2011 (Figure 16). Photo monitoring demonstrated the

shifting of the thalweg away from the toe of the streambank (Figure 17). In 2011, two additional flow events that went over the top of the streambank occurred and resulted in erosion beginning to occur behind both weirs three and four (Figure 18). Flow events in spring 2012 continued to erode these areas that are not protected because farm rock weirs are not keyed into the streambank and this erosion will eventually result in the failure of this project unless repairs are made.

Figure 17. Photo monitoring of weirs four and five at the Weaubleau Creek rock weir project. (A) Prior to construction October 2005. (B) Post-construction September 2006. (C) Channel changes October 2007. (D) Following failure of weir five May 2008. (E) Following project repair October 2008. (F) Post-flow November 2010.

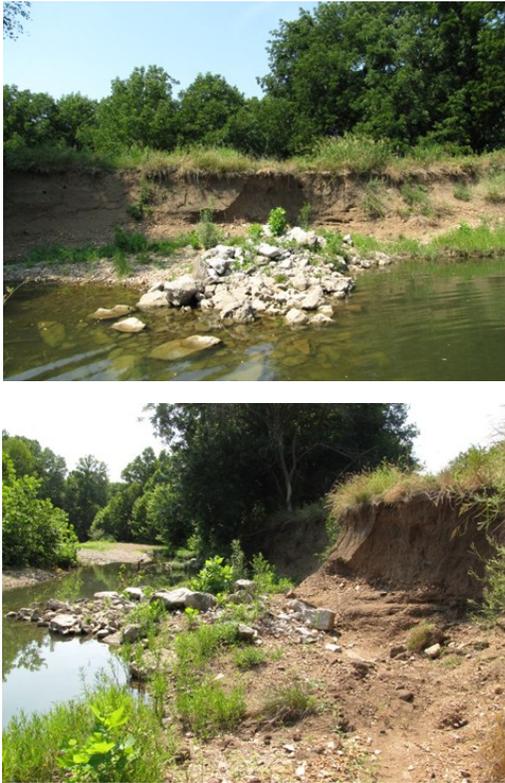
Figure 18. Erosion of key of weir three at the Weaubleau farm rock weir project June 2012. (A) Weir three from across the channel. (B) Looking upstream at weir three.

maintained their length since repair. However, in 2011 and 2012 the upper streambank behind weirs three and four began to erode and the project appears to be failing a second time due to the lack of streambank keys. At Middle Fork we attempted to apply the lessons learned from the other projects and build the weirs longer than initially planned in order to account for the anticipated length that would be lost. During the initial high flow events, the area behind the weirs began to erode and allowed flow to work behind the weirs causing the project to fail. The Middle Fork project demonstrates that while it is important to account for length that may be lost using the farm rock weir approach, it is also important not to over build the weirs.

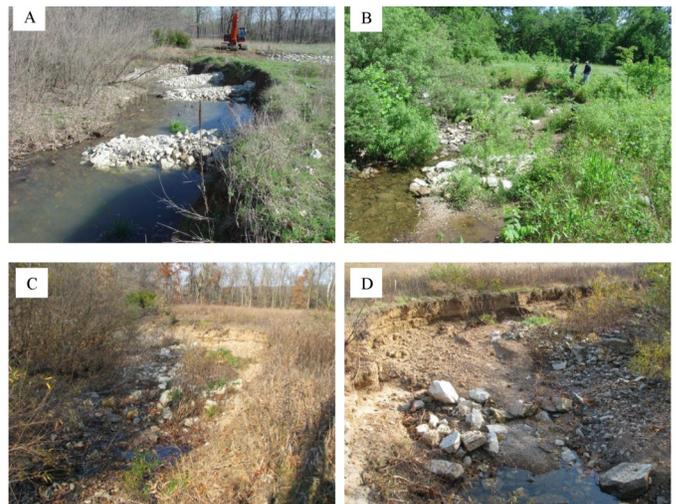
The Middle Fork project failed for the same reason as the Weaubleau Creek project, the lack of keys, but at this site there were other contributing fac-

Photo monitoring does give a good indication of what caused the failure (Figure 20). The weirs at this project were built longer than originally intended due to the loss of length expected based on what we observed at other projects. Instead of extending $\frac{1}{2}$ way across the base flow wetted channel these weirs extended across $\frac{2}{3}$ to $\frac{3}{4}$ of the wetted channel width. Photos taken after construction show that much of the rock in the weirs was smaller than the cobble of the streambed and the vegetated cobble bar when the project was constructed in spring 2007. 2007 was a very dry year on this creek with there being virtually no flow from mid-summer until the spring of 2008 that resulted in vegetation beginning to establish in the base flow channel (Figure 19). The initial high flow events in February and April of 2008 caused the upper streambank area to start eroding and allowed flow to start working behind the weirs. Once this process started it could not be stopped by the project because there were no keys protecting the weirs. When an additional high flow event occurred in the summer of 2008 it resulted in the failure of weirs three, four, and five (Figure 21). Ultimately, the project failed because the lack of keys, the rock used for the weirs, and the unvegetated eroding streambank were less resistive to the erosional forces than were the streambed and the vegetated and consolidated cobble bar. From a construction standpoint, the most significant factors were the lack of keys, the incorrect length of the weirs, the size of the rock used, and the fact that farm rock was not graded to a standardized specification that allows the rock to interlock and hold together better. As a result of these design flaws the project could not withstand the velocities without washing away. The decision was made following failure not to repair this project but instead to use a more traditional approach to fixing this bank.

Figure 20. Middle Fork farm rock weir project. (A) Looking downstream following construction in April 2007. (B) June 2008. (C) Following project failure in November 2008. (D) Looking upstream following project failure November 2008.

account for the expected loss in length; however, building the weirs extra-long at this project actually resulted in the project failing. There were several factors that contributed to the failure 1) the overextended weirs blocked too high a percentage of the channel backing up the flow and making it look for an easier path, 2) lack of keys in the streambank allowed the flow to divert into the streambank and around the weirs, 3) the lack of streambank and riparian vegetation on the eroding streambank created a situation where there were virtually no resisting forces in comparison to the well vegetated opposite bar, and 4) since the farm rock was not graded to a standardized specification that allows the rock to interlock and hold together better, it could not withstand the velocities and washed away. The project demonstrates that you will need to balance the potential for the weirs to lose length while not over building them. The lack of bed and streambank keys makes the farm rock weir approach extremely vulnerable to failure even with proper project design in terms of placement and weir length.
