Science and Management Technical Series

Number 9

Experimental Farm Rock Toe Protection as an Erosion Control Option for Missouri Streambanks

J. Persinger, K. Grmusich, C. Culler, and B. Jamison

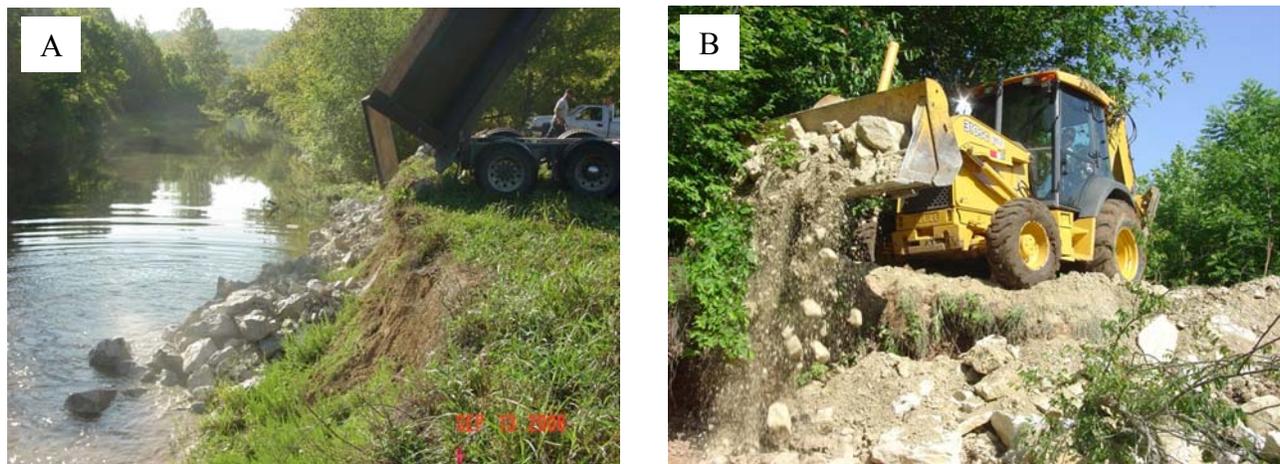
Figure 2. Rock being dumped at the toe of the bank. (A) Dump truck used during project construction at Weaubleau Creek. (B) Backhoe used during project construction at Sulphur Branch.

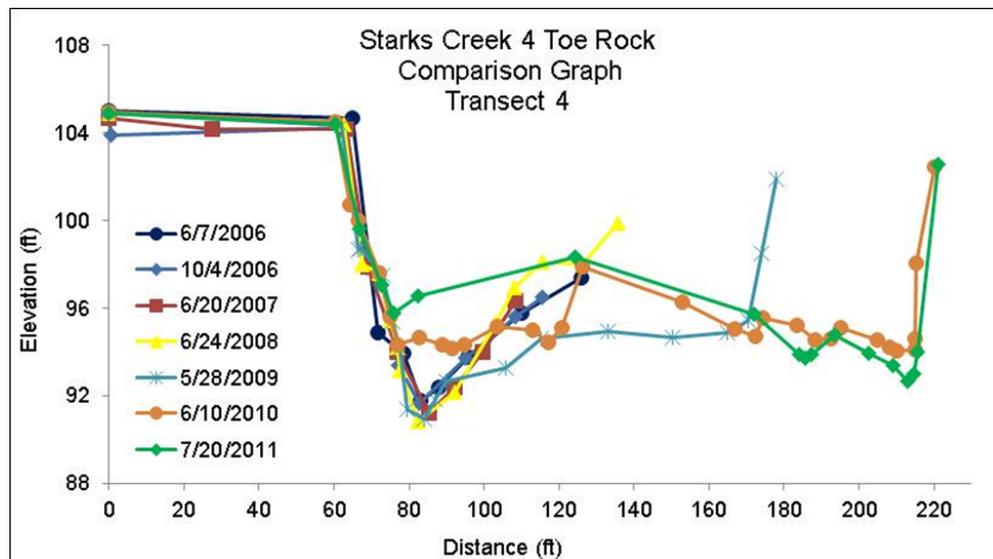
Despite large amounts of erosion occurring on the banks surrounding this project, this site has remained stable. For the first two and a half years the project survived numerous high flows and performed as planned. The thalweg shift that occurred in 2009 resulted in large amounts of deposition at the toe of the streambank and between the streambank and the new channel. The physical surveys, which were conducted post-construction and following flow events each year from 2007-2011 show how the channel shifted away from the bank. The original thalweg that was against the streambank has filled in with deposition and in places it has shifted more than 100 ft. away from the bank. The survey data appear to show that there has been erosion at the toe of the streambank for five of the seven transects (Table 2). However this movement is actually due to deposition of material that has formed a new gravel bar in front of the eroding streambank and that has covered up the original toe of the bank, resulting in the toe moving back and up the streambank (Figure 7). This is confirmed by the fact that the slope has been reduced for six of the seven transects with the other transect remaining the same.

Figure 7. Physical survey data for transect four covering the pre-construction survey (6/7/2006), post-construction survey (10/4/2006), and five post-flow surveys (6/20/2007, 6/24/2008, 5/28/2009, 6/10/2010, and 7/20/2011).

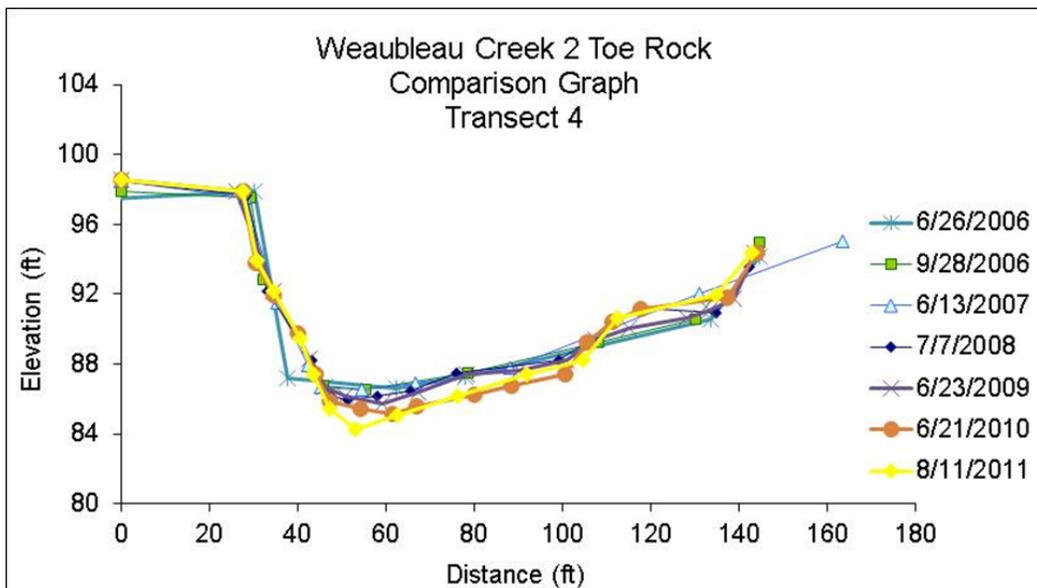
The physical surveys, which were conducted pre-construction, post-construction and following flow events each year from 2007-2011, show the streambank stability since project construction. We have seen a small amount of erosion at the top of the streambank for all transects and deposition at five of the six transects (Table 3). The apparent deposition is due to the toe rock settling into areas of scour and not due to deposition of new sediment, but there was enough rock in place for it to do this without affecting the project's ability to protect the bank. Streambank movement resulted in a slight reduction in streambank slope that was evident for five of the six transects. Transect four gives a good example of how the addition of the toe rock and the small amount of erosion at the top of the streambank has resulted in a streambank with a more moderate slope (Figure 10). The reduced slope along with vegetation establishment has made this project successful.

Figure 10. Physical survey data for transect four covering the pre-construction survey (6/26/2006), post-construction survey (9/28/2006), and five post-flow surveys (6/13/2007, 7/7/2008, 6/23/2009, 6/21/2010, and 8/11/2011).

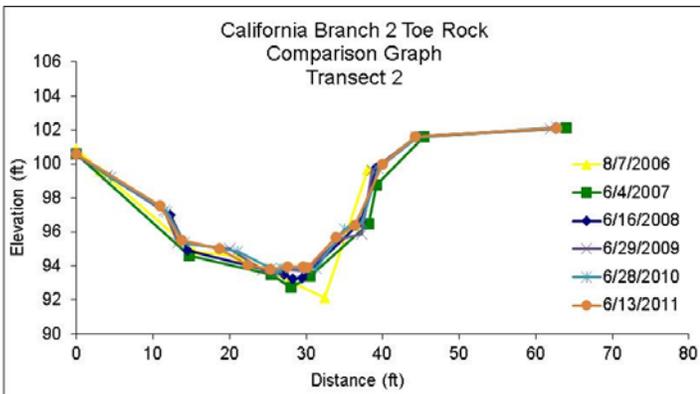
rock size. The rock used was simply not large enough to stay in place and was picked up and moved downstream. Insufficient rock size appears to be the biggest issue with the approach of using shot rock instead of rip rap to build farm rock toe projects. The physical surveys, which were conducted post-construction and following flow events each year from 2008-2011, demonstrate the lack of streambank movement and the stability of the channel despite the loss of rock (Figures 15). Streambank movement has been minimal and was caused almost exclusively by the loss of rock. This rock loss has resulted in a slight increase in streambank slope along transects five and six (Table 5). The slope of the streambank at the other transects has remained virtually unchanged and vegetation is beginning to establish in the toe rock that is still in place.

Figure 15. Physical survey data for transect two showing the pre-construction survey (8/7/2006), post-construction survey (6/4/2007), and four post-flow surveys (6/16/2008, 6/29/2009, 6/28/2010, and 6/13/2011).

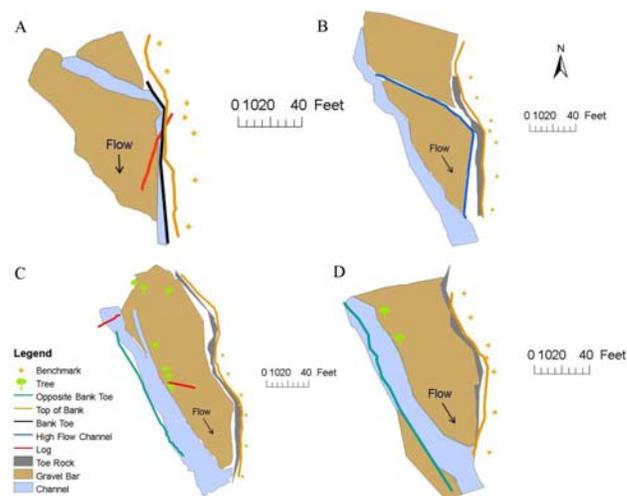
Immediately following project construction and prior to the post-construction survey, a high flow event occurred at this site and caused major changes to the channel. Although this event was less than a $\frac{3}{4}$ streambank full flow event, it was large enough to cause a shift in the channel (Figure 16). The thalweg switched from running against the toe of the streambank to a previous high flow area of the channel behind the gravel bar (Figure 19).

Post-construction monitoring did not occur until July 2008. The multiple high flow events that occurred throughout the rest of 2008, 2009, 2010, and 2011 worked to stabilize the stream in its new path. Initially the low flows continued to use the area along the project, but flow events in 2010 caused the original thalweg to fill in so much that it is almost nonexistent and is no longer even acting as a high flow channel. A comparison of the pre-construction survey data with the post-construction and post-flow survey data show the dramatic shift following the flow events. Transect one is located just downstream of

Figure 19. GPS maps of Fiery Fork 3 farm rock toe project. (A) Pre-construction August 2007. (B) Post-construction August 2007. (C) Post-flow May 2010. (D) Post-flow June 2011.

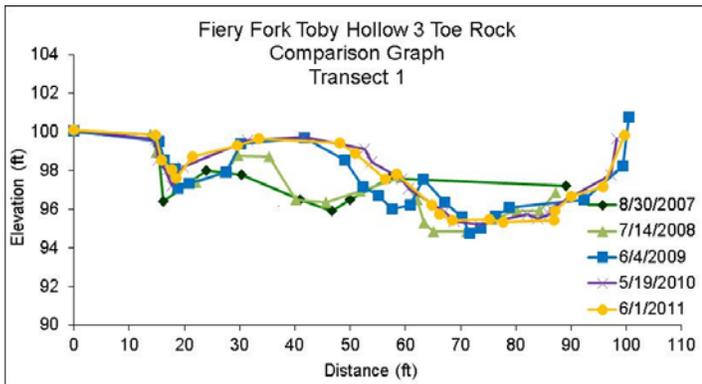
where the shift occurred (Figure 20). The survey data show where the back side of the gravel washed out causing the thalweg to shift away from the bank. Transect three shows the distance the thalweg has moved away from the streambank and the deposition that has occurred (Figure 21).

Figure 20. Physical survey data for transect one for the pre-construction survey (8/30/2007), post-construction survey (7/14/2008), and three post-flow surveys (6/4/2009, 5/19/2010, and 6/1/2011).

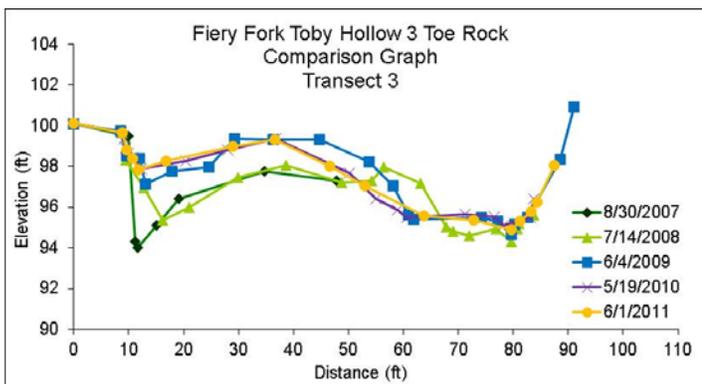
Figure 21. Physical survey data for transect three for the pre-construction survey (8/30/2007), post-construction survey (7/14/2008), and three post-flow surveys (6/4/2009, 5/19/2010, and 6/1/2011).
