Science and Management Technical Series

Number 8

Experimental Farm Rock Weirs as an Erosion Control Option for Missouri Streambanks

J. Persinger, K. Grmusich, C. Culler, and B. Jamison

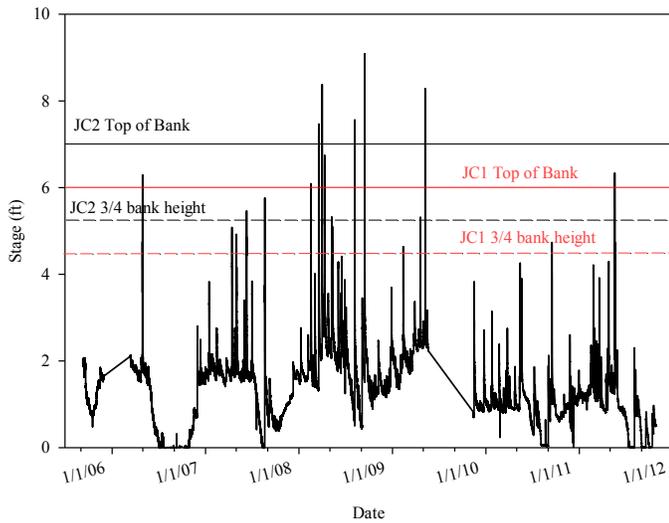
The Jakes Creek Site 1 project has experienced numerous flow events (Figure 2). These included a flow event in the spring of 2006 that caused the log weir project downstream to fail. There were also six flow events in 2008 and one in 2009 that reached stages higher than the top of the eroding streambank (6 ft.). The largest recorded flow to test this project occurred in September 2008. The stream's stage rose from 1.6 ft. to 9.1 ft. in six hours, representing a stage 3 ft. above the top of the eroding bank. In 2009, a large flow event occurred sometime between June and October that caused the Levelogger® to be lost. Because of that, there is no flow record for that time period. In 2010 and 2011 there was only a single flow event greater than the top of the streambank that tested the project.

Figure 2. Levellogger® data from Jakes Creek for fall 2005 through 2011. Data are missing from May 2009 until November 2009 due to a lost Levellogger®. The red solid and dashed lines represent the top and $\frac{3}{4}$ of the streambank height at Jakes Creek site 1. The black solid and dashed lines represent the top and $\frac{3}{4}$ of the streambank height at Jakes Creek site 2.

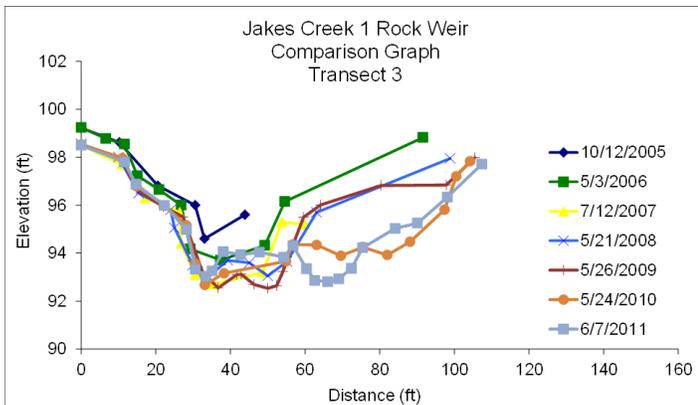
Weir two lost approximately 7 ft. of length between project construction and the 2008 physical sur-

vey (Figure 3); however, the weir had been built longer than the original design and the project was still working as expected so there was no plan to repair the project. An unplanned repair was made to weir two between October 2008 and March 2009. The repair consisted of adding approximately 4 ft. of length back to weir two (Figure 4). The repair was made by area staff without consulting with the rest of the project team.

Figure 3. Physical survey data for transect three, which runs down the center of weir two, for the post-construction survey (10/12/2005) and six post-flow surveys (5/3/2006, 7/12/2007, 5/21/2008, 5/26/2009, 5/24/2010, and 6/7/2011).

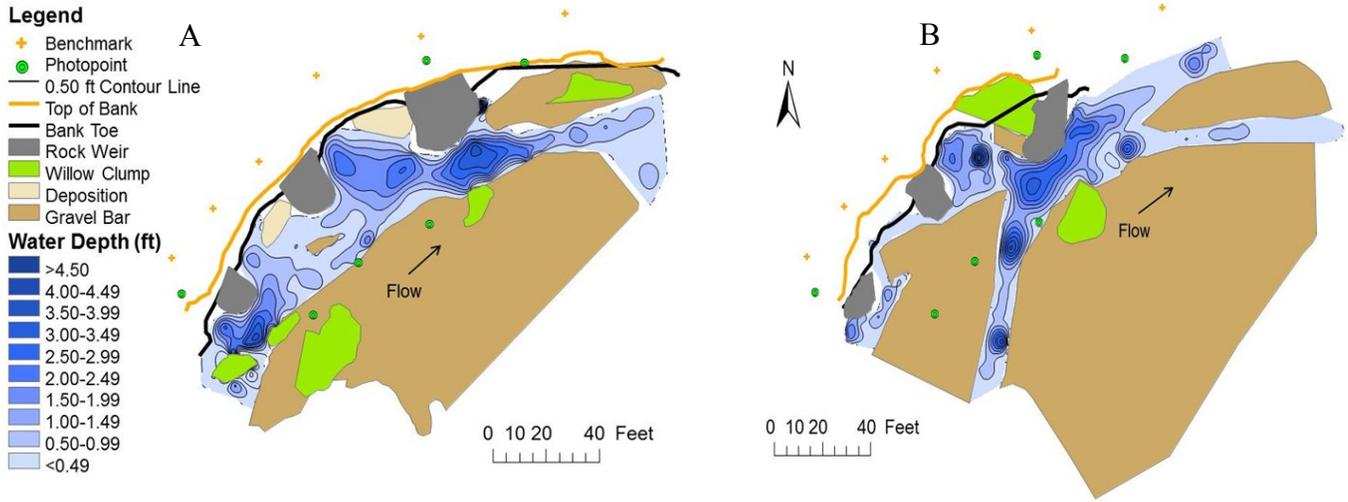
A GPS map of the distribution of water depths in the channel shows the thalweg has moved away from the toe of the streambank and out beyond the tips of the weirs (Figure 6). During the 2009 flow event that resulted in the loss of the Levellogger®, the main flow of the channel shifted away from the project and now flows through what was middle of the opposing gravel bar. The channel shift was caused by changes upstream of the project. Since 2009, the redirected flow through the bar has accelerated deposition between weirs one and two. So far this change in flow approach has benefited the project, but the new angle of approach could eventually cause problems for weir three since low flow is no longer being affected by weirs one and two. These channel changes are shown in the physical surveys (Figure 3). Details on streambank movement along each transect indicates the streambank has remained stable with only the most downstream transect showing any change as a result of erosion (Table 2). The streambank slope has been reduced for the two transects between the weirs and for the transect located downstream of the last weir.

Figure 6. Channel depth profile map of Jakes Creek site 1 rock weir project (A) May 2009 and (B) June 2011.

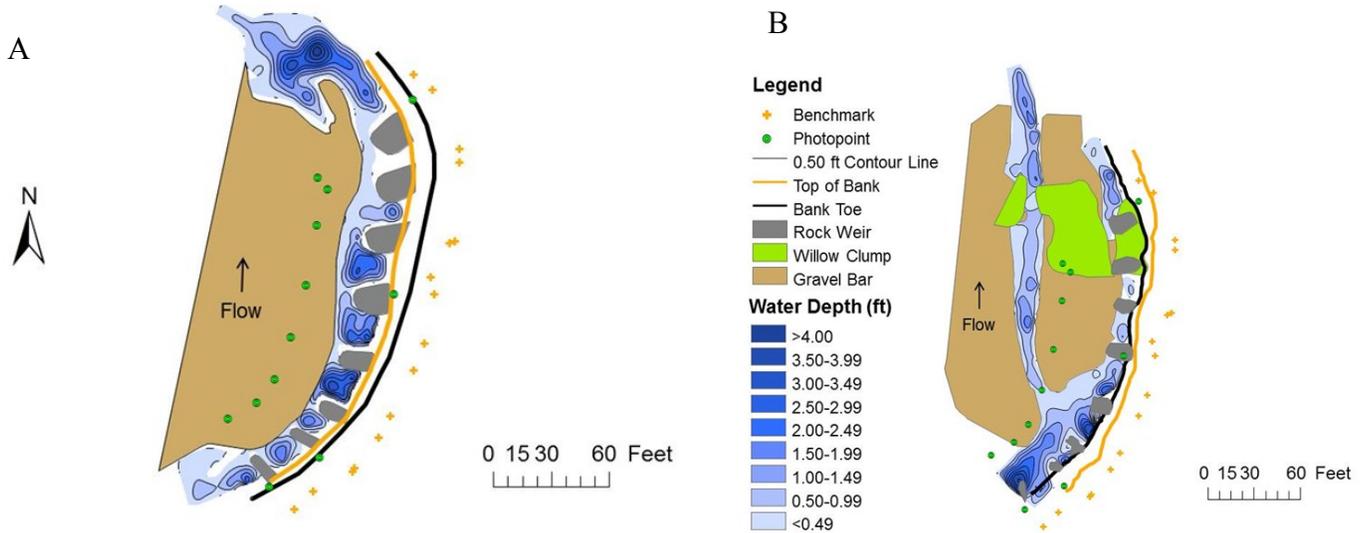
Figure 7. Jakes Creek site 2 farm rock weir project GPS map including depth profile. (A) February 2007. (B) June 2011.

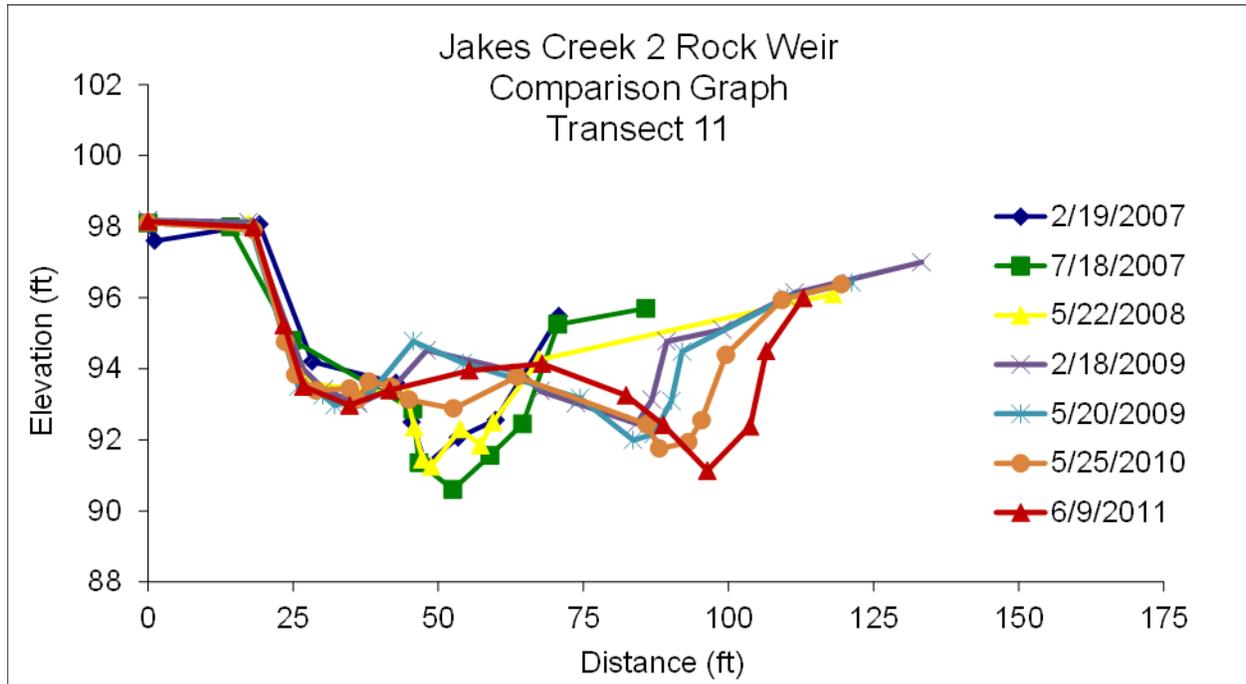
Figure 9. Survey data for transect 11 for the post-construction survey (2/19/2007) and six post-flow surveys (7/18/2007, 5/22/2008, 2/18/2009, 5/20/2009, 5/25/2010, and 6/9/2011).

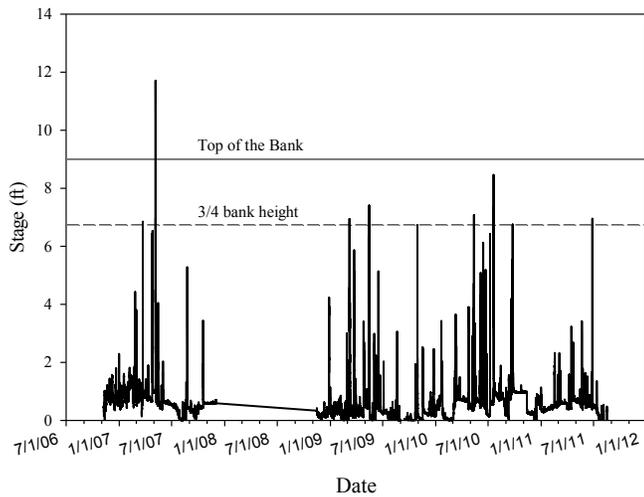
Figure 10. Levellogger® data from Dry Branch for 2006-2007 and 2009-2011.

construction survey was completed on December 3, 2007. During 2008, the rebuilt project experienced multiple flow events. Unfortunately we have no data on the exact sizes of these flow events because Levelogger®s were lost on two separate occasions. Post-flow monitoring occurred on August 4, 2008 to track project performance since reconstruction. In late 2008, a new Levelogger® was placed in the stream. From 2009 through 2011, Dry Branch had seven flow events that reached a stage height greater than $\frac{3}{4}$ the streambank height (Figure 10). During these flow events the project lost length off the tips of the weirs. Weir one has lost most of its length and is now little

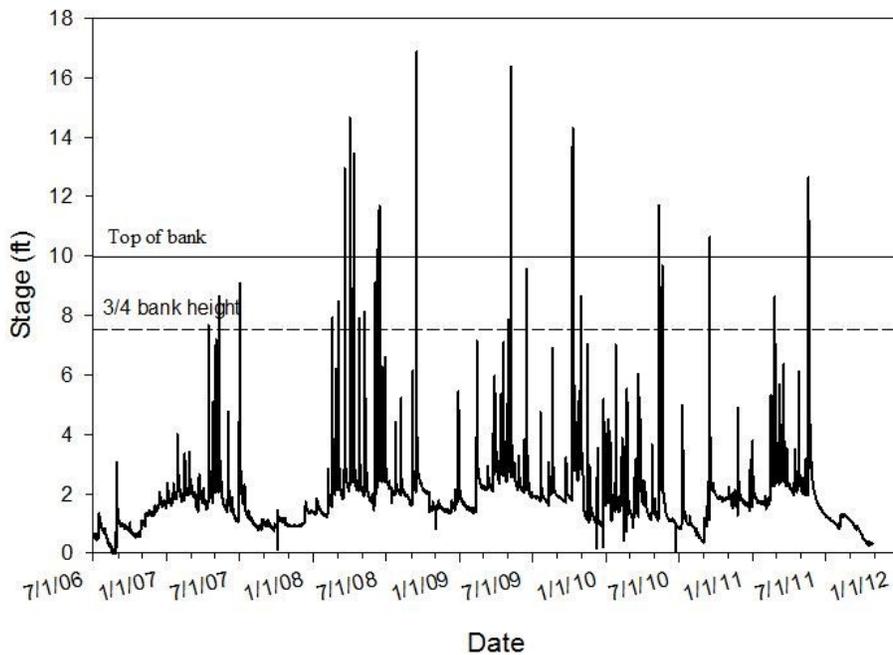
The Weaubleau Creek project experienced three flow events that were more than $\frac{3}{4}$ the streambank height in 2007 as well as two more in early 2008 (one of which went over the top of the bank, 10 ft.) before failing at the end of March in 2008 (Figure 13). The project started to fail during this flow event due to changes that had occurred as a result of previous flow events. Because farm rock weirs are not initially keyed into the bed of the stream the way that traditional bendway weirs are, the streambed around the tip of the weir developed a scour hole from velocity currents going around the weir. The rock off the tip of the weir

Figure 13. Levellogger® data from Weaubleau Creek for 2006 through 2011.

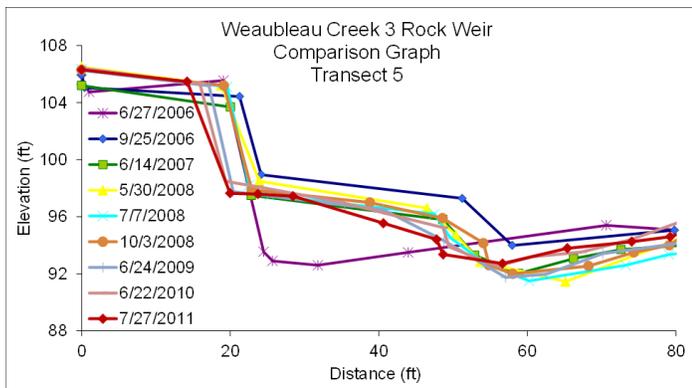
then fell into the hole created by the scour and eventually protected itself from any further scour. However; this process causes the weir to lose some of its effective length. In this case, weirs three and four lost enough length to allow flow to get behind weir five (Table 6, Figures 14, 15). The loss of length caused weir five to fail.

Figure 14. Transect five survey data for Weaubleau Creek. Transect five runs across the middle of weir three. Survey data from pre-construction survey (6/27/2006), post-construction survey (9/25/2006), and seven post-flow surveys (6/14/2007, 5/30/2008, 7/7/2008, 10/3/2008, 6/24/2009, 6/22/2010, and 7/27/2011).

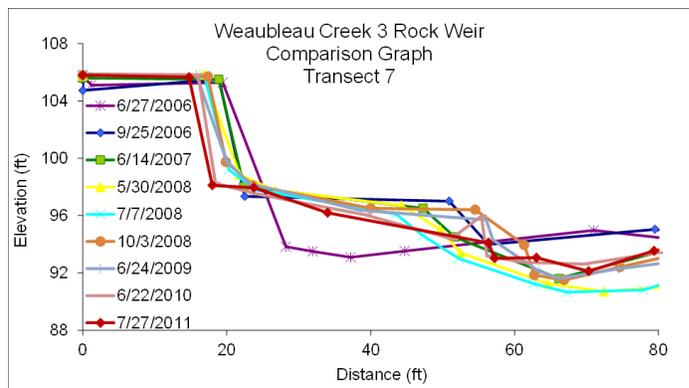
Figure 15. Transect seven survey data for Weaubleau Creek. Transect seven runs across the middle of weir four. Survey data from pre-construction survey (6/27/2006), post-construction survey (9/25/2006), and seven post-flow surveys (6/14/2007, 5/30/2008, 7/7/2008, 10/3/2008, 6/24/2009, 6/22/2010, and 7/27/2011).

Despite flow getting behind weir five, the rest of the project performed as planned. The thalweg had shifted away from the eroding streambank and deposition occurred between all other weirs. As a result, the project was repaired by rebuilding weir five and adding length to weir four in August 2008. After repairs were completed, the largest flow occurred in September 2008 and the project survived without further damage. The project was tested by two flows greater than the top of the bank, one of which was over 16 ft. in stage in 2009, and by three more flows that were greater than the top of the streambank in 2010. Despite the failure and repairs to fix weirs four and five in 2008, this project appeared to be working prior to 2011 (Figure 16). Photo monitoring demonstrated the

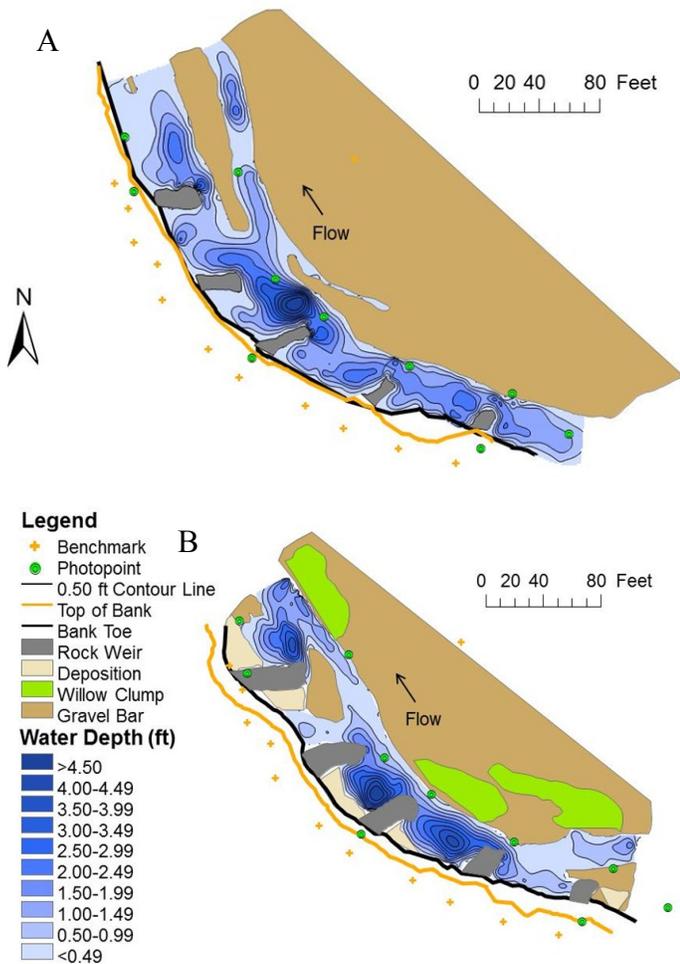
Figure 16. Channel depth profile map of Weaubleau Creek rock weir project. (A) June 2007. (B) June 2010.

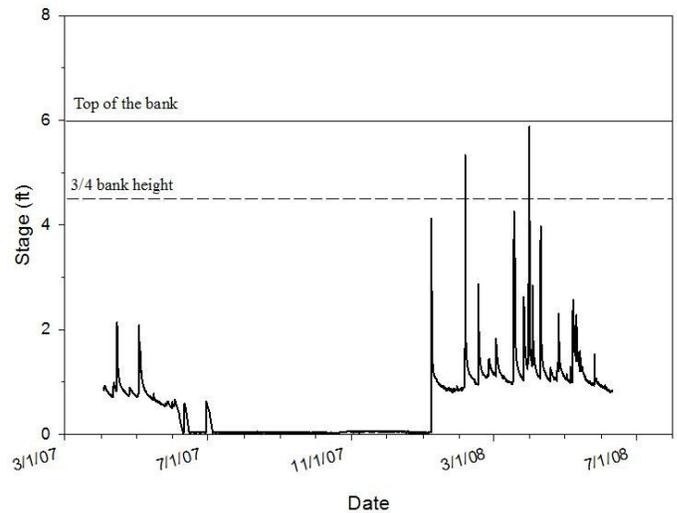
tors. The first two flow events that reached a height greater than $\frac{3}{4}$ the streambank height occurred in February and April 2008 (Figure 19). These flow events began the failure process. A later flow event caused the complete failure of the project. The size of flow that caused the complete failure is unknown because it took out the root wad where the Levellogger® was attached and the Levellogger® was not recovered.

Figure 19. Levellogger® data from Middle Fork for 2007 - 2008.

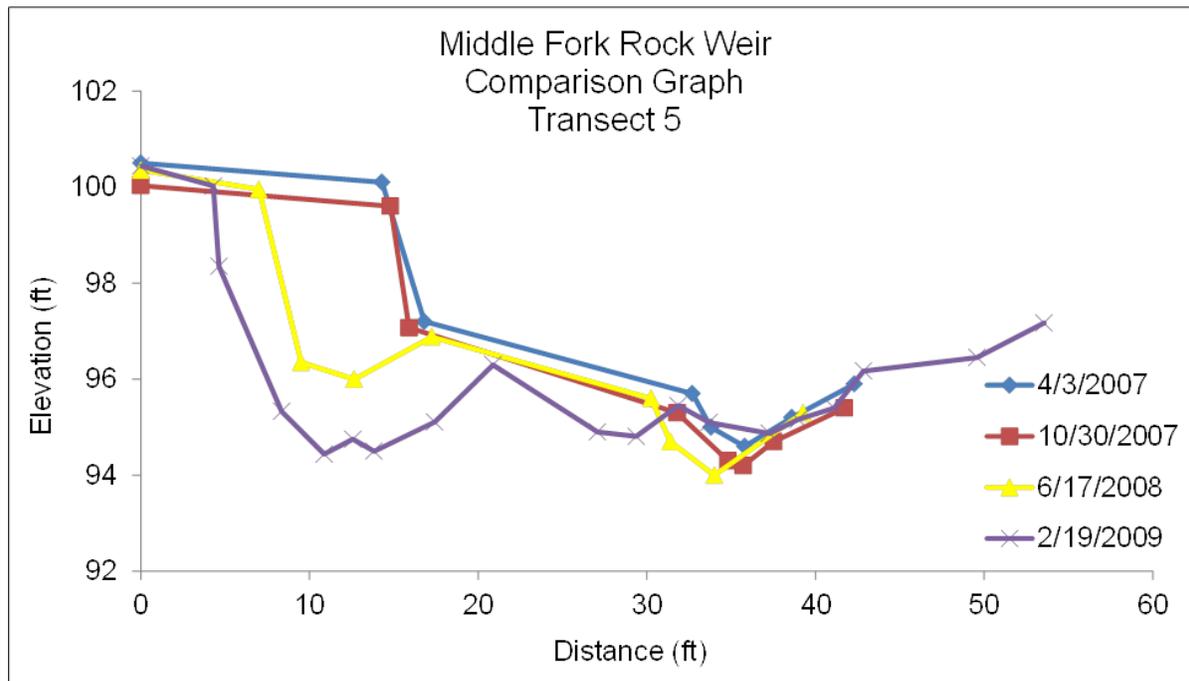
Figure 21. Survey data for transect five for the post-construction survey (4/3/2007) and three post-flow surveys (10/30/2007, 6/17/2008, and 2/19/2009).
